Complaint Against the Valuation of Real Property

Subject: Preliminary Report – Bates Property
Property Owners: Shawn & Sherri Bates

**Preliminary Report
Of
Surface Property Damage
At the
Shaun & Sherri Bates Property
(51620 Township Road 146 B)**

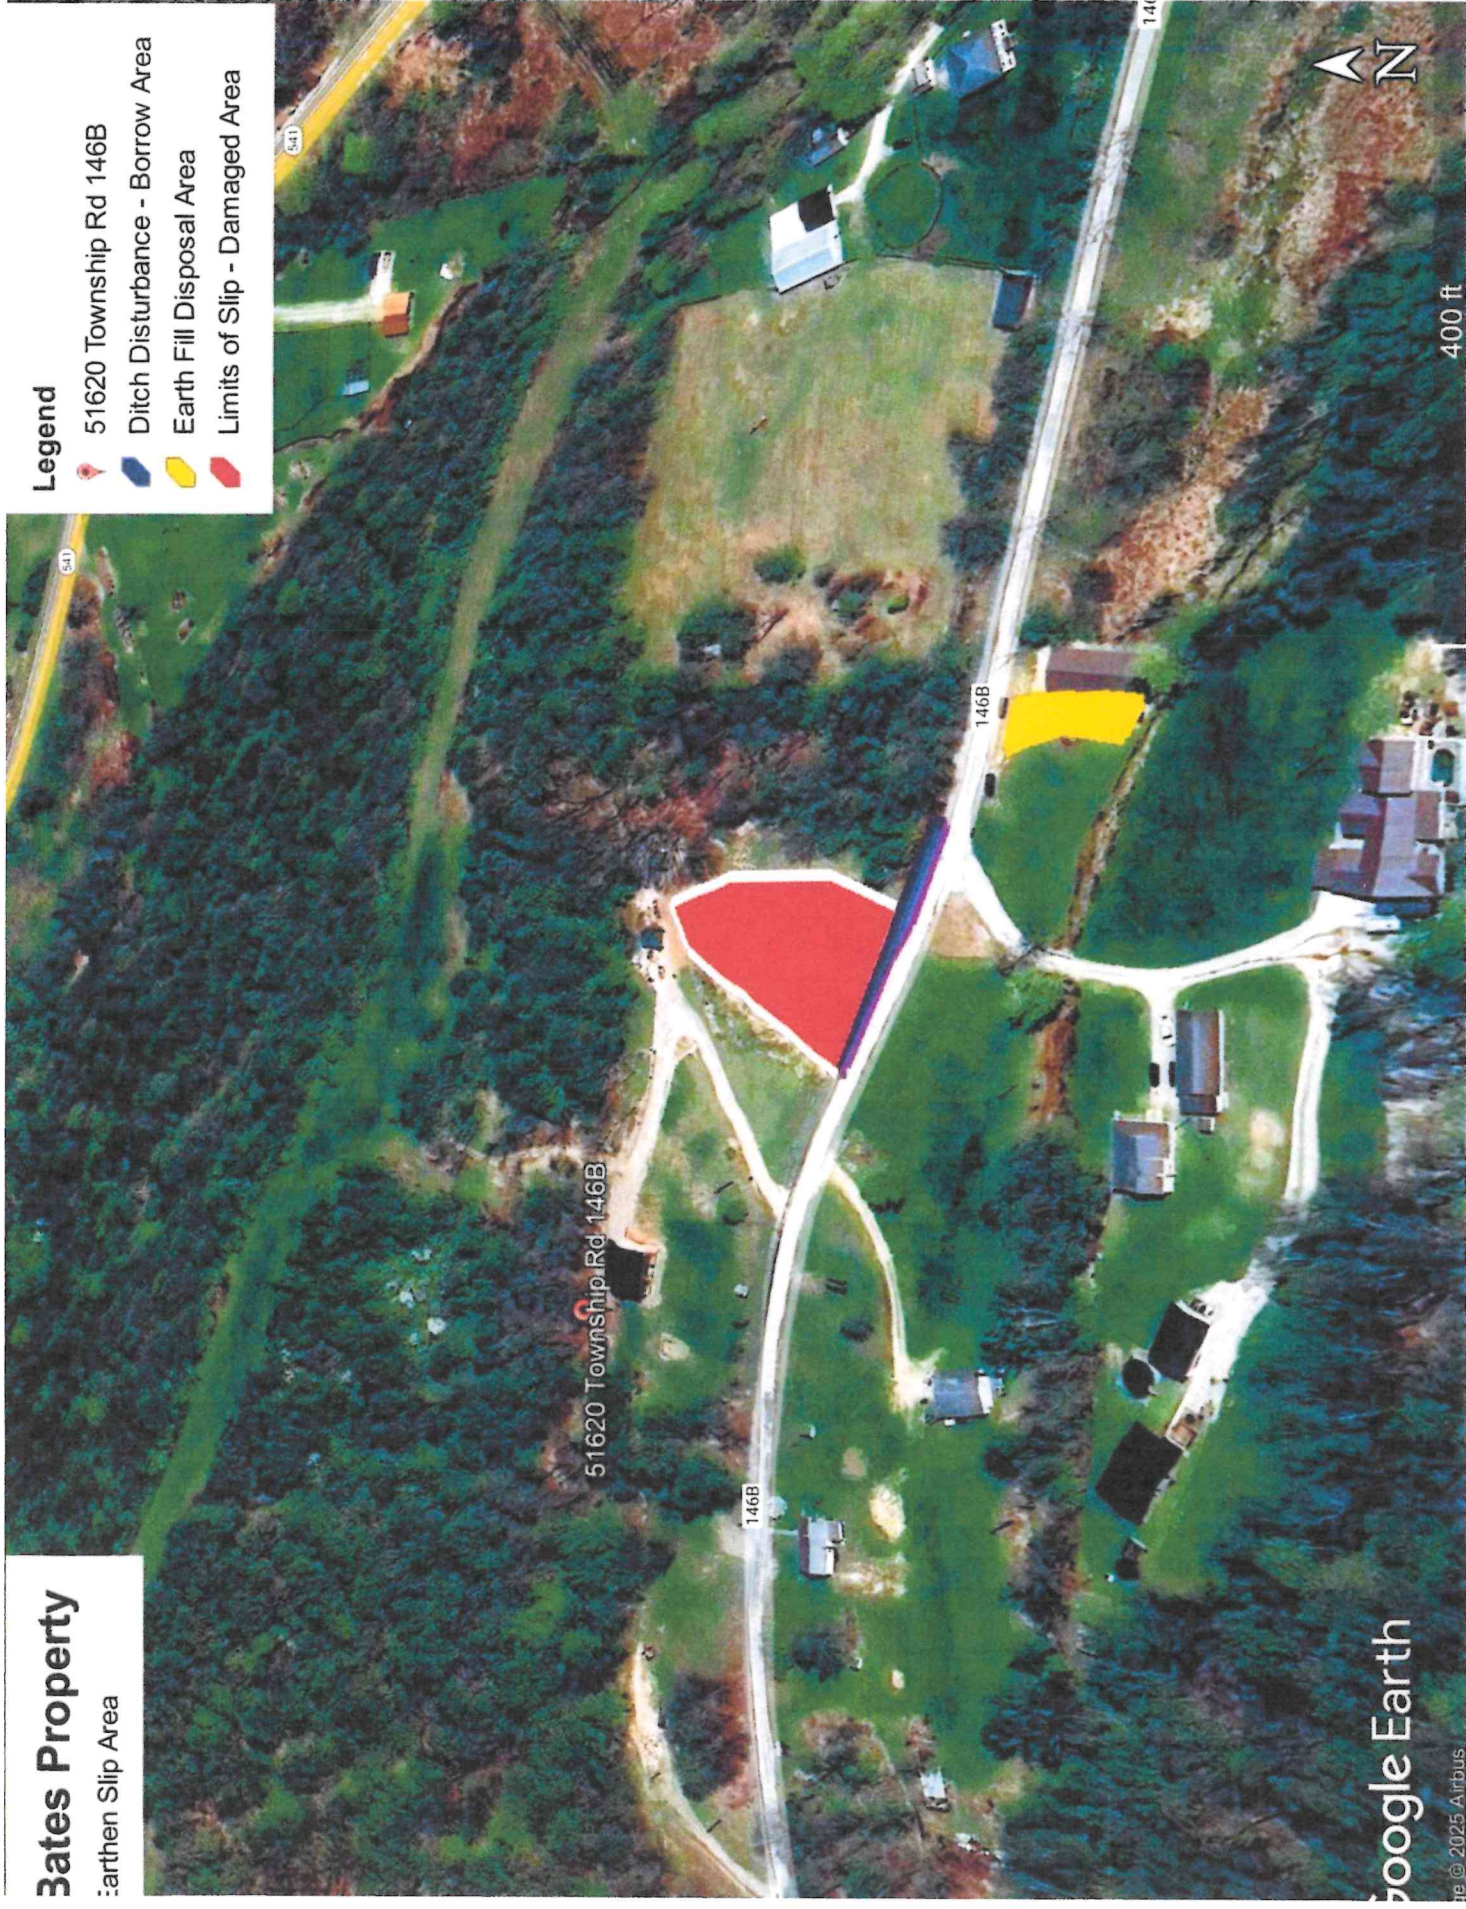
earthen Slip Area

All of the earthen material that was removed from the north side of the township road created an unconfined vertical free face. This vertical free face is approximately 225 ft in length and varies between 1.5 ft. to 7 ft. in height. This vertical free face with the assistance of rainwater and surface drainage caused an earthen slip to occur on the earthen slope located north of the Township Road ditch line.

possible. It is estimated that approximately 300 to 350 cubic yards were moved to the fill site located across the road. The movement of this material created a slip area where the damage occurred was approximately 0.35 acres in size.

- 51620 Township Rd 146B
- Ditch Disturbance - Borrow Area
- Earth Fill Disposal Area
- Limits of Slip - Damaged Area

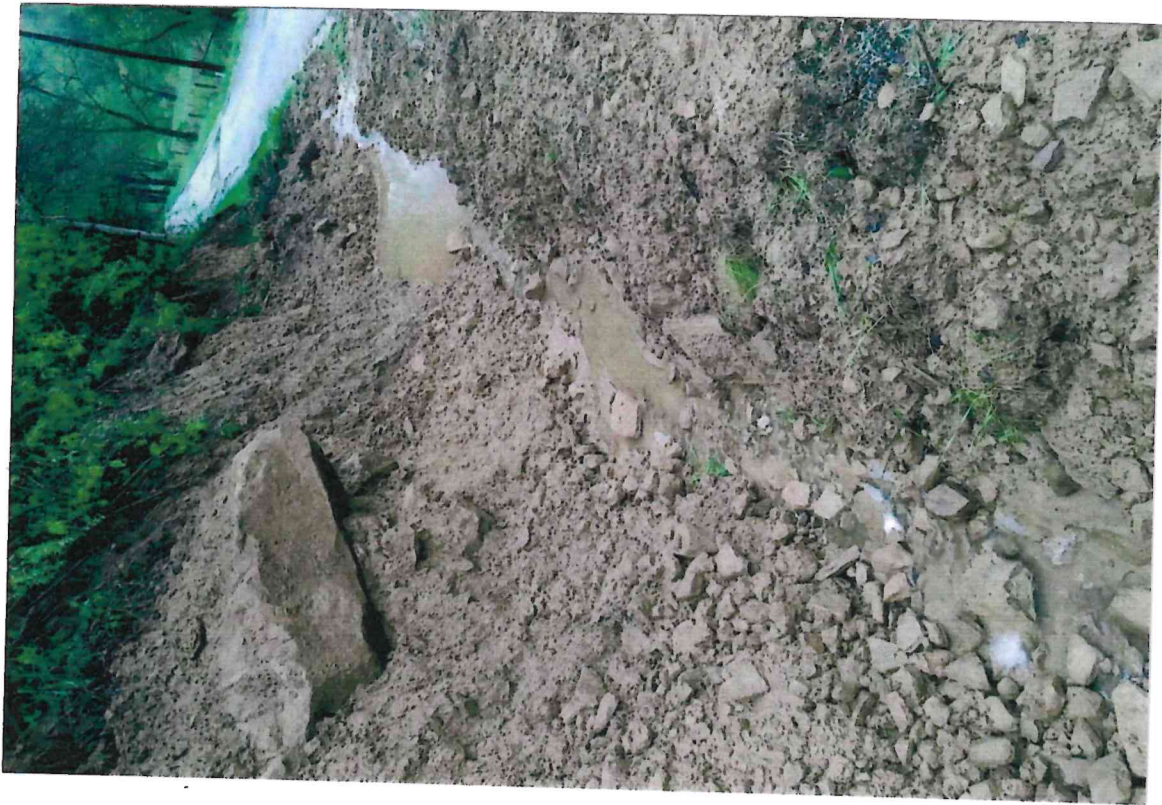
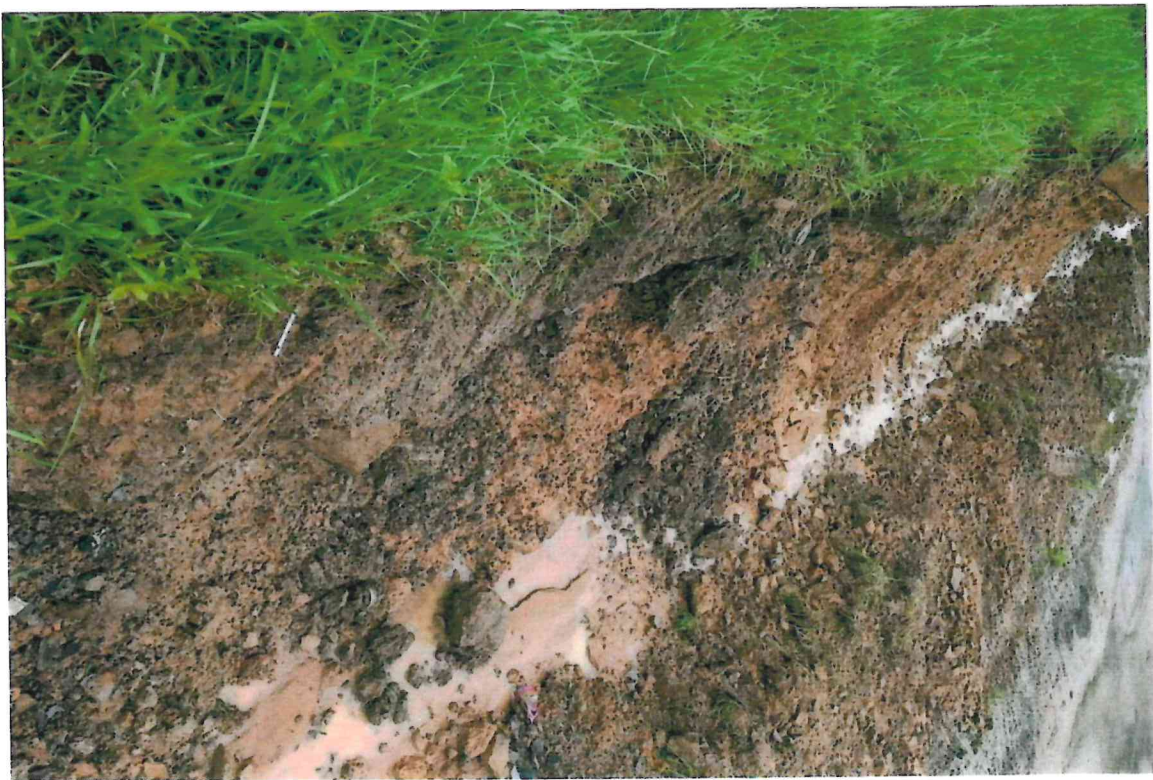
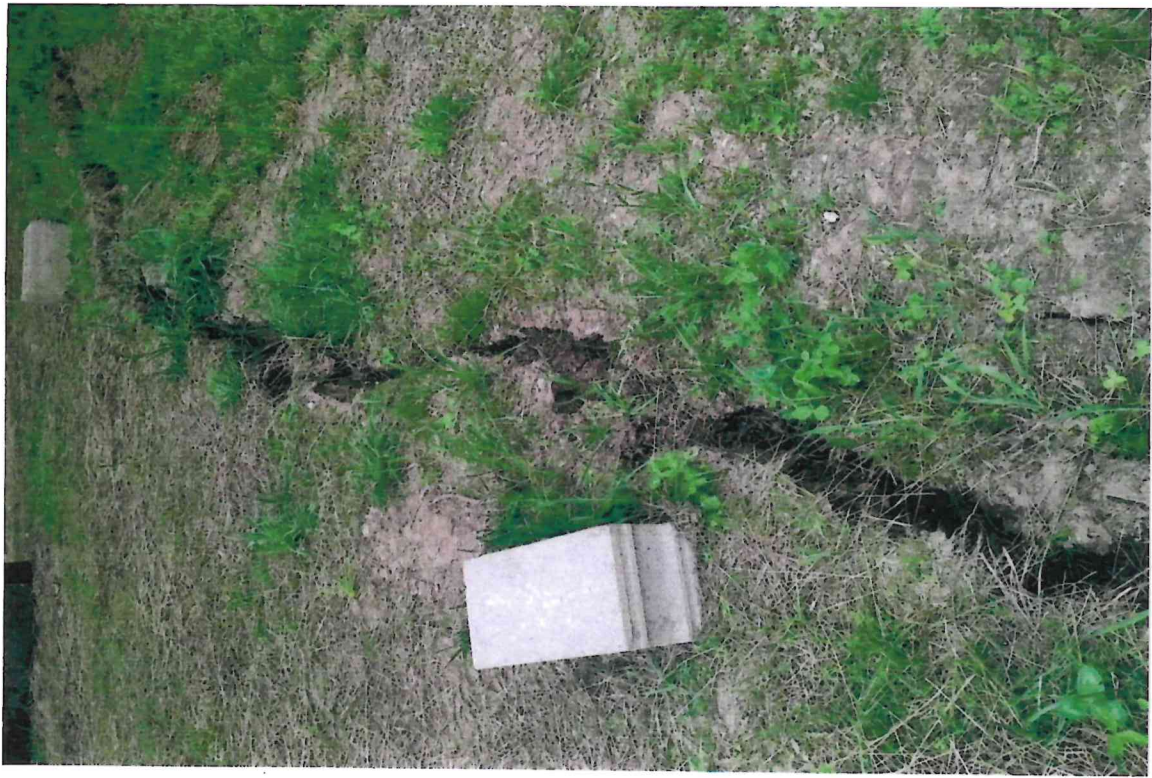
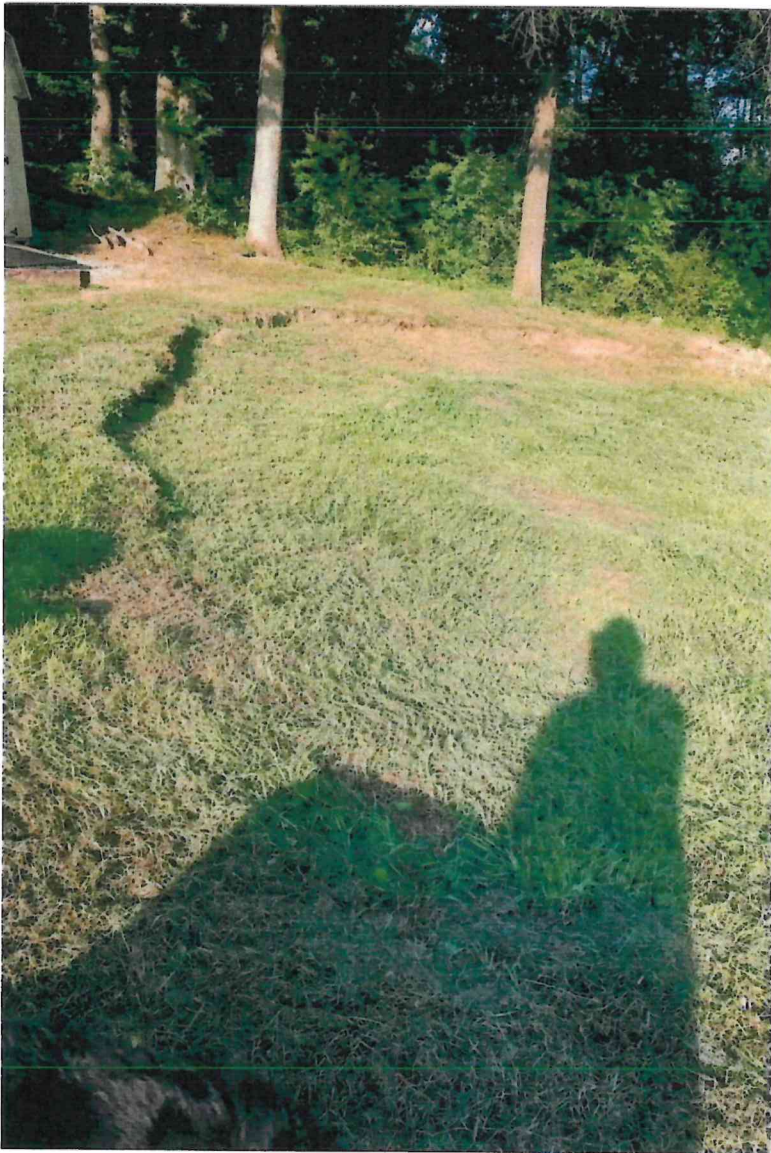
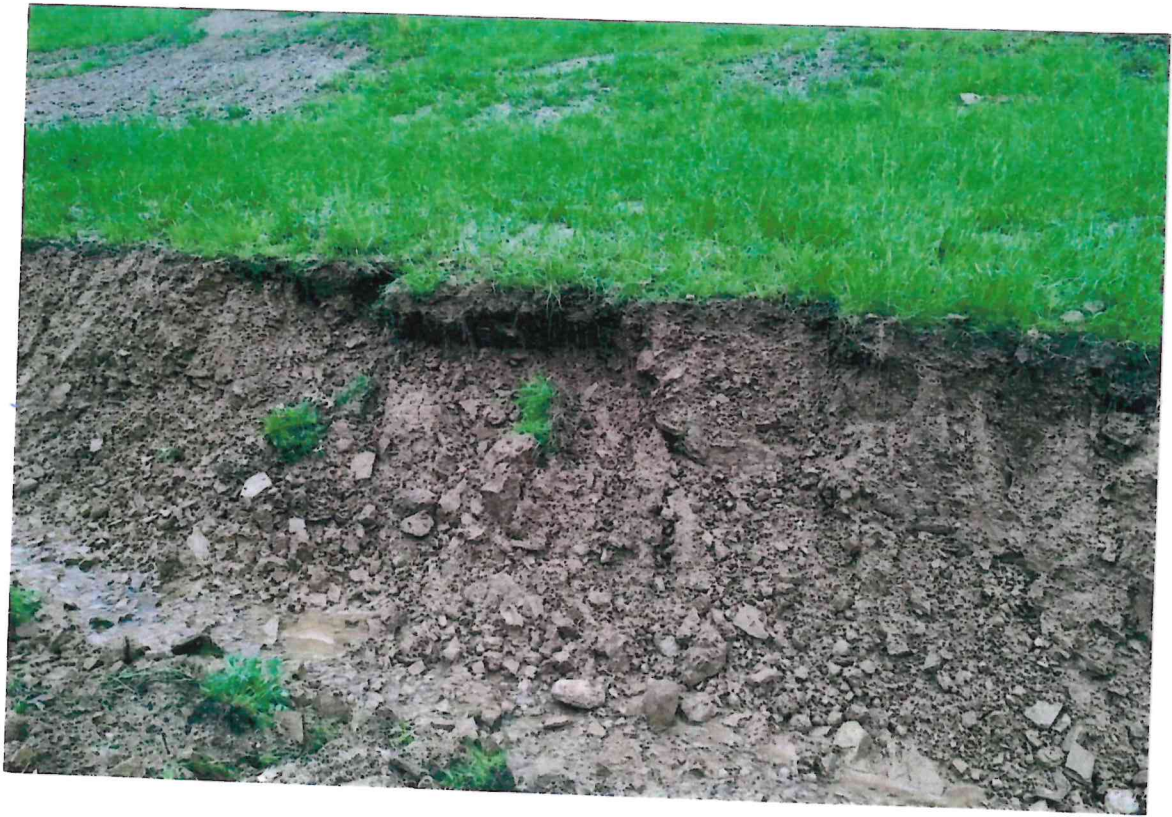
It was evident during the field review that the slip damage caused on the Bates property was due to the recent work done along the Township Road. All of the slip damage that occurred was in line with the recent disturbance along the road. Areas where there was no slip damage there was no disturbance which occurred along the township road.

The township did not perform any reclamation or remedial work to the disturbance that they created. Also, they did not do anything to mitigate or lessen the affects of the unconfined vertical face that they created. Further the modified ditch line now has a changed elevation profile. This profile in the middle of the disturbance is now lower which will cause standing water along the road to occur and will significantly damage the existing township road over time. The potential road damage that will occur will most likely be road surface cracking, surface depression, and erosion.

2. The slip damage area is approximately 0.35 acres in size and is currently active. Since this area is active which means, it will continue to move and creep downwards towards the county road. Therefore, no surface structures or buildings can be constructed overtop of the damaged area until the damaged area is permanently repaired.

3. The cost to repair the slip damaged area would be significant. An order of magnitude estimate would range between \$15,000 and \$20,000. This would include all of the repair earthwork, the installation of water underdrains, perimeter ditches, terraces, and possible installation of a retaining wall or rip-rap at the base of the damaged area. This repair cost does not include any repair or remedial work needed within the limits of the Township Road right-of-way.

4. Remedial and repair work will also have to be done within the limits of the Township Road right-of-way. Primarily the ditch line will have to be reworked and brought to the correct grade. Also, the existing vertical free face along the north side of the ditch line will have to be graded and tapered to a minimum of a 2:1 side slope. Further surface cracking along the road surface will need to be repaired.
